PRYDNIPROVSKA STATE ACADEMY
OF CIVIL ENGINEERING AND ARCHITECTURE
UKRAINE

MALACKY – PROJECT PROPOSALS ON IMPROVING THE ENVIRONMENT QUALITY IN BETHANY CENTER

AUTHORS OF PROJECT:

Valeriia POTOTSKA
Anna HLUSHCHENKO

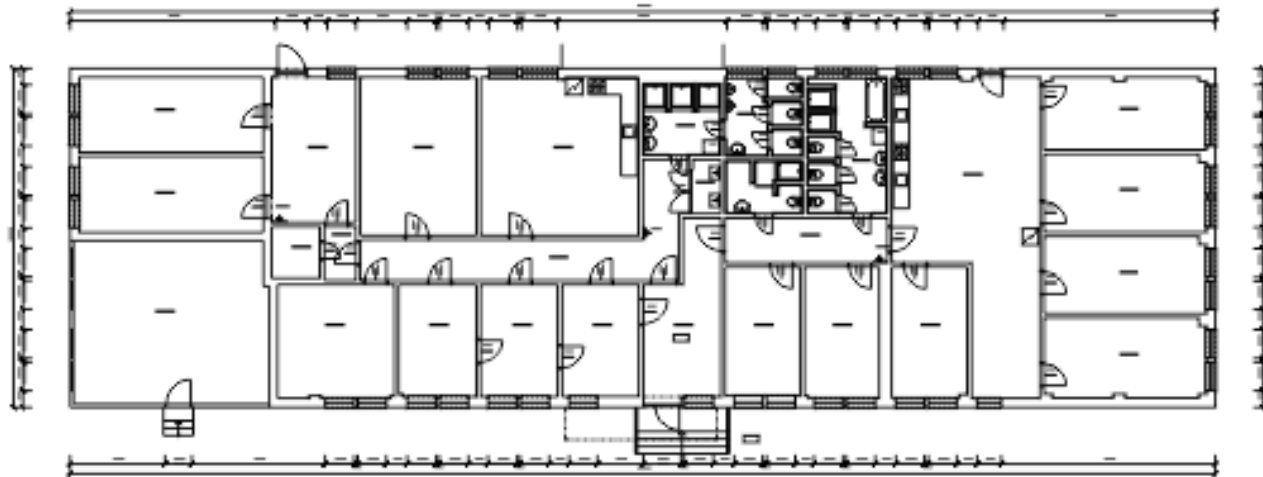
plan at mark 0.000

Explication:

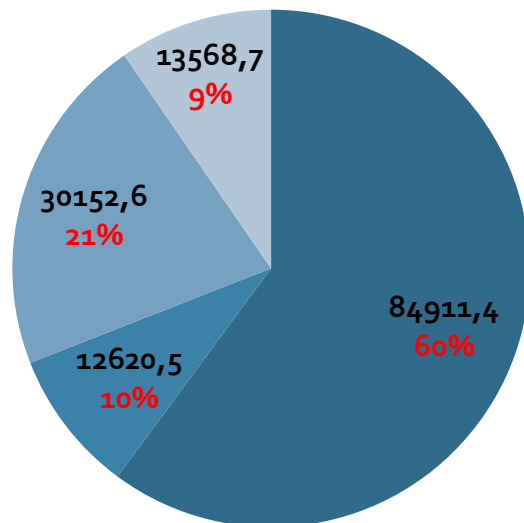
- heat losses through external walls
- heat losses through windows and doors
- heat losses through flat roof
- heat losses through the floors

Heat losses through Center's building envelope during the heating period, 141253,2 kW·h, %

Heat losses through Center's building envelope during the heating period

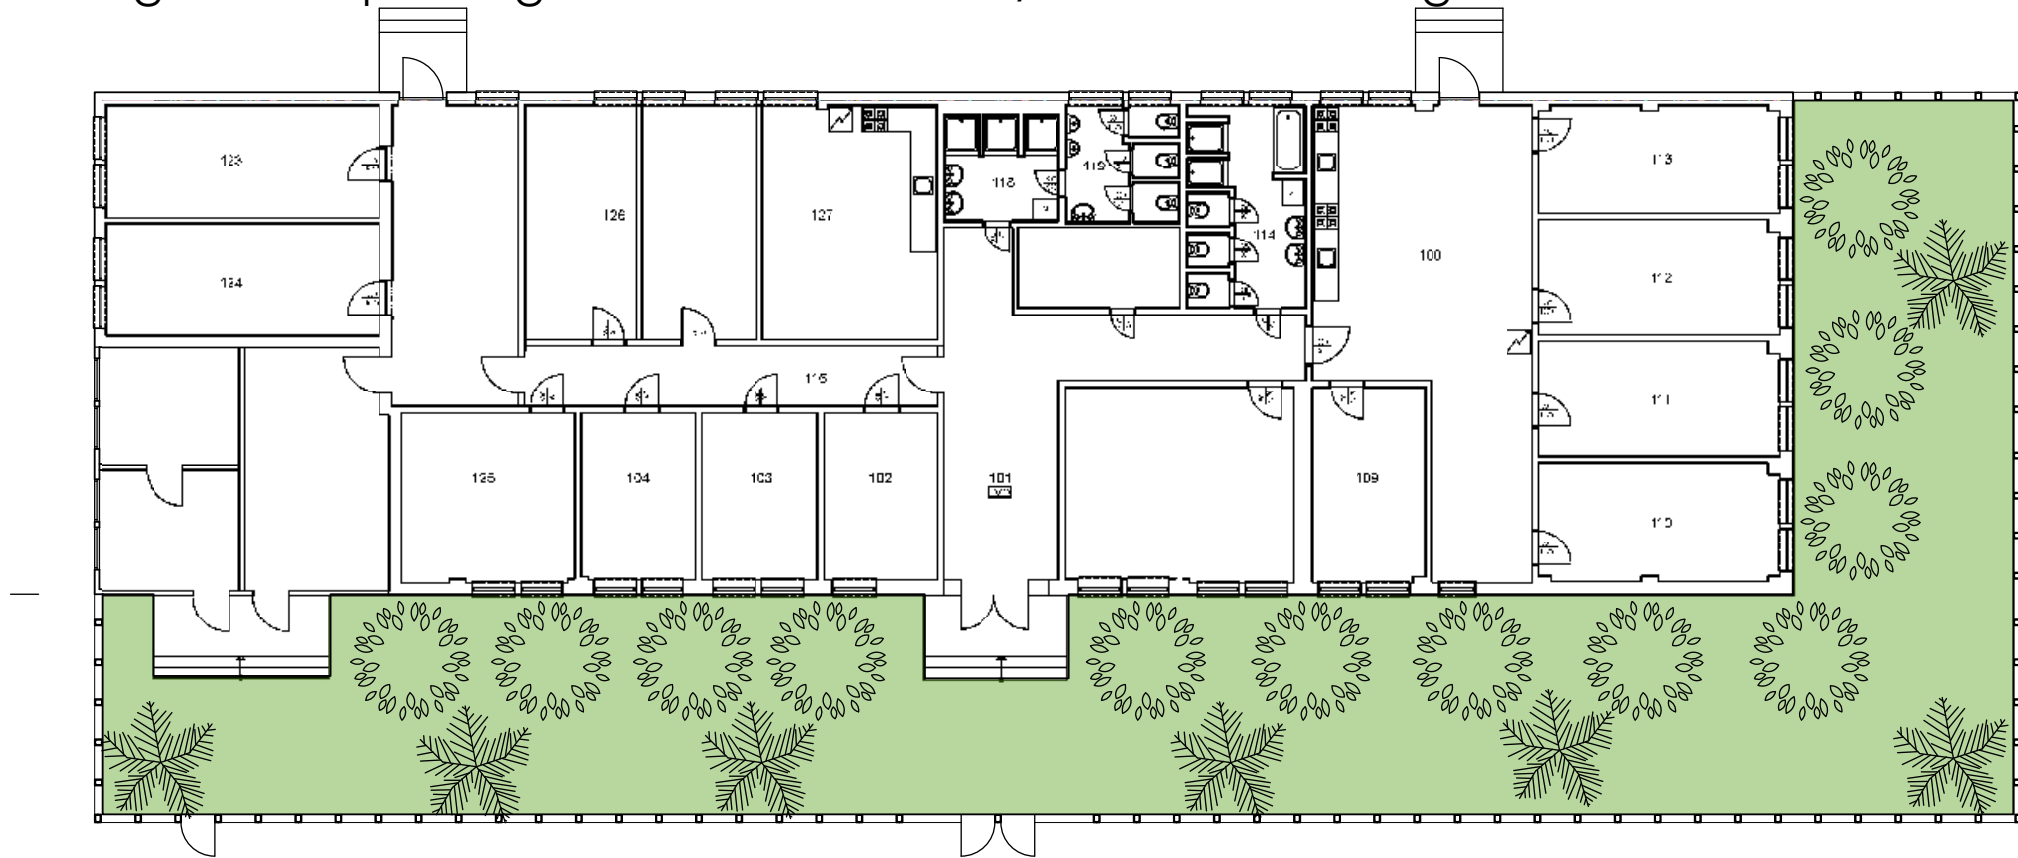
2. Redesign and reprofiling of room + extension/extension of the greenhouse

Explication

101. Entrance hall	109. Room	117. Psychologist's office
102. Tech Room	110. Room	118, 119. Medical service
103. Shower for men	111. Room	120. Office
104. Male bathroom	112. Room	121. Office
105. Female bathroom	113. Room	122. Room
106. Library	114. Room	123. Room
107. Room	115. Room	124. Kitchen
108. Kitchen	116. Room	125. The entrance hall
		126. Corridor

- Insulation of envelope;
- Combined a greenhouse with building;
- Internal redesign and opening medical room;
- Improvement of the surrounding area, creation of recreational zones, playgrounds and landscaping.

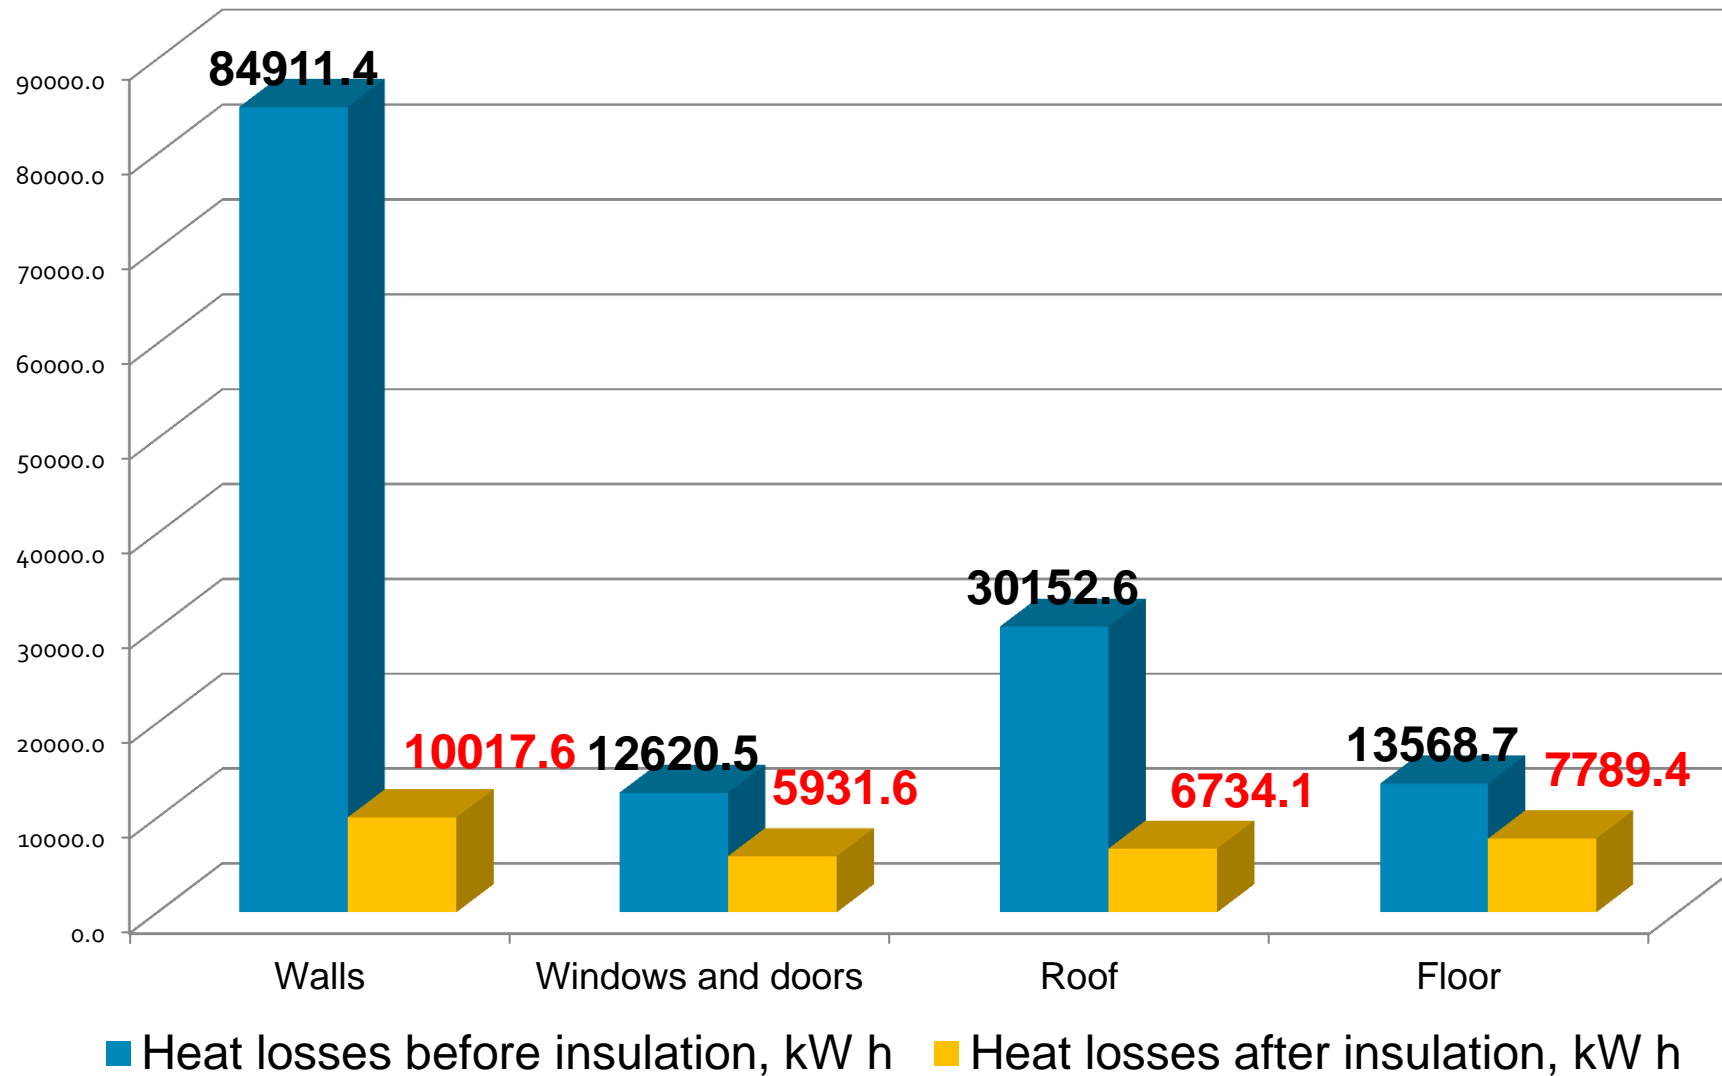
3. Heat losses through envelope of the Center **BEFORE** and **AFTER** thermal insulation

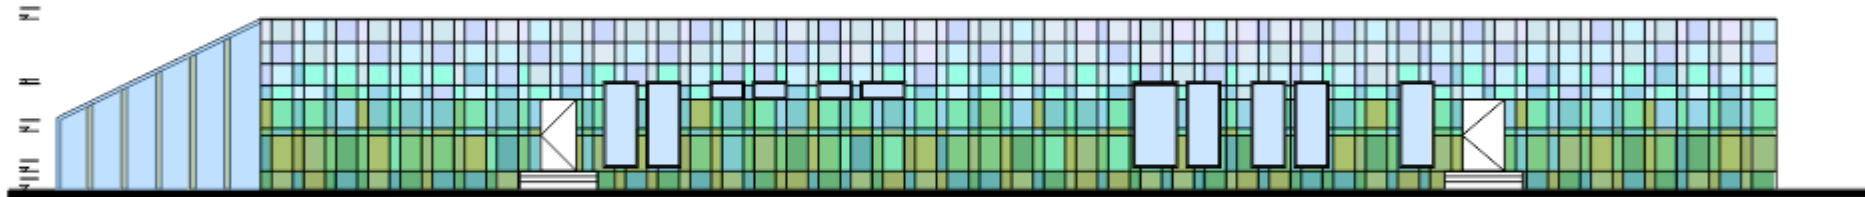
POHLAD ČELNÝ - JUŽNÝ

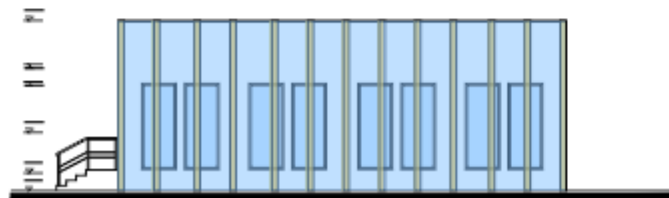
POHLAD ZADNÝ - SEVERNÝ

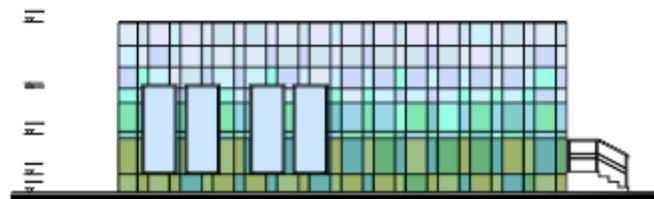
POHLAD BOČNÝ - VÝCHODNÝ

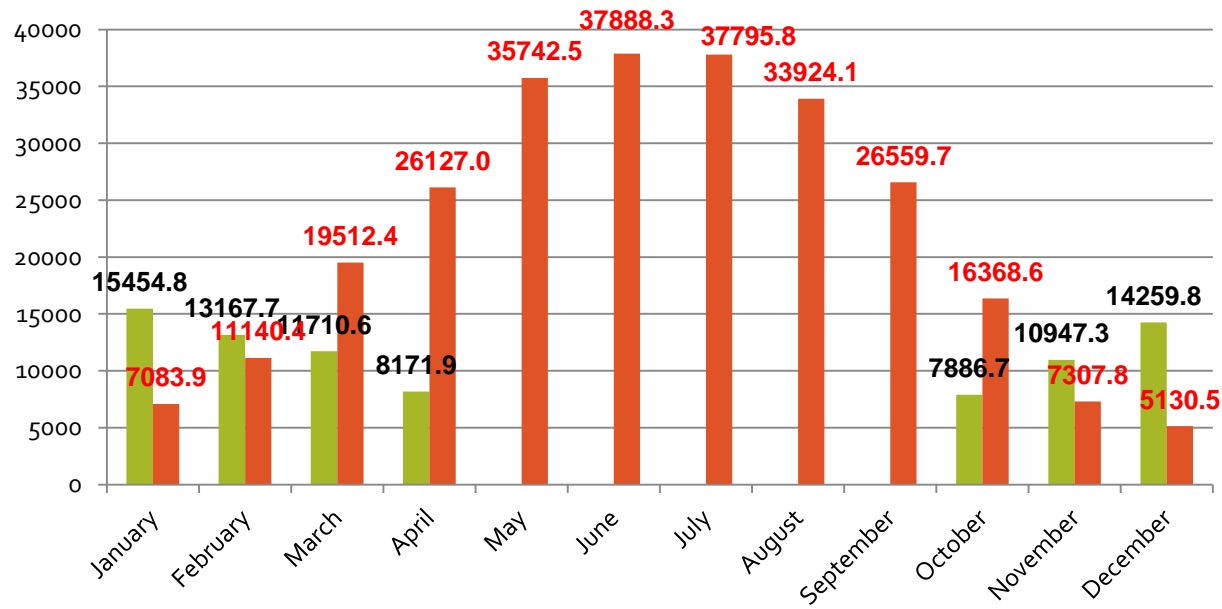
Option 1

- Heat losses from external envelope of attached greenhouse, kW h
- Solar heat input through translucent constructions of attached greenhouse, kW h

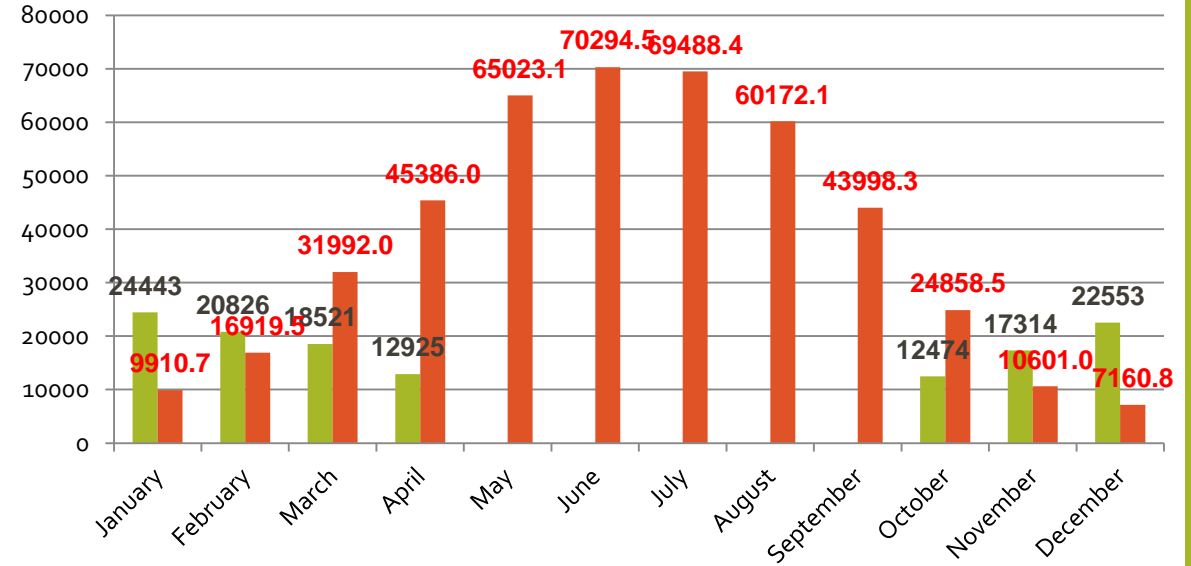
Option 2

- Heat losses from external envelope of attached greenhouse, kW h
- Solar heat input through translucent constructions of attached greenhouse, kW h

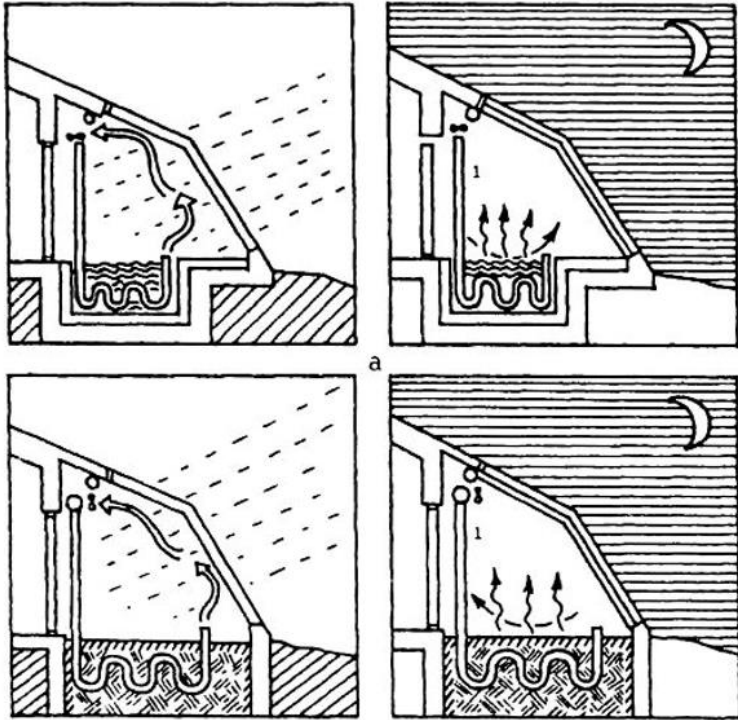
Using soil as heat accumulator

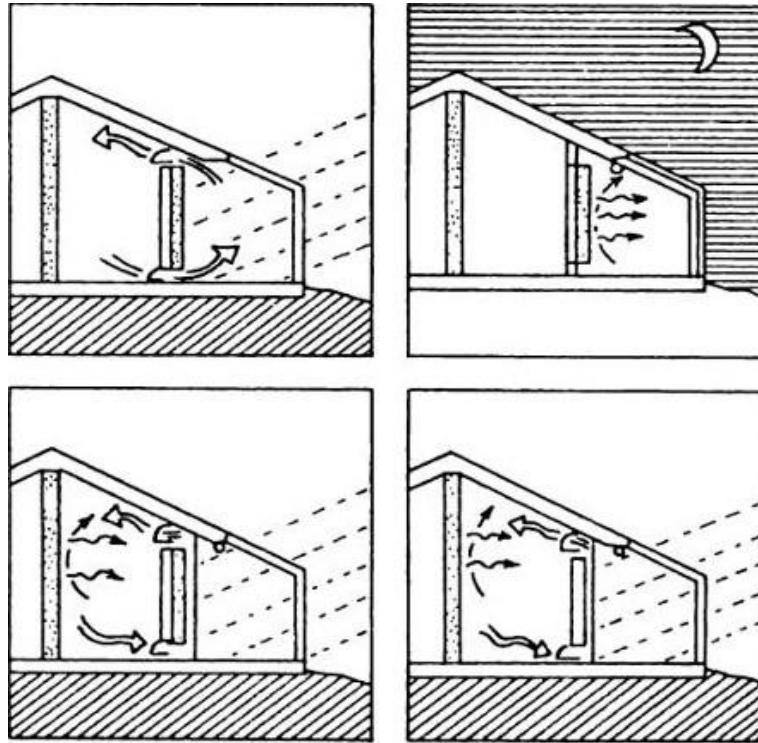
Stone wall as a heat accumulator

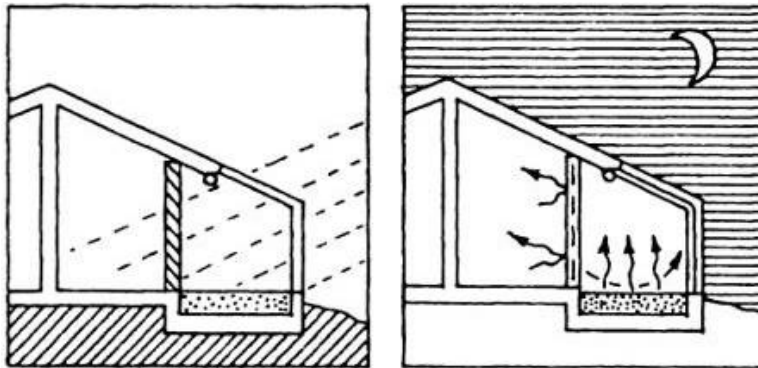
Accumulation of heat stone floor

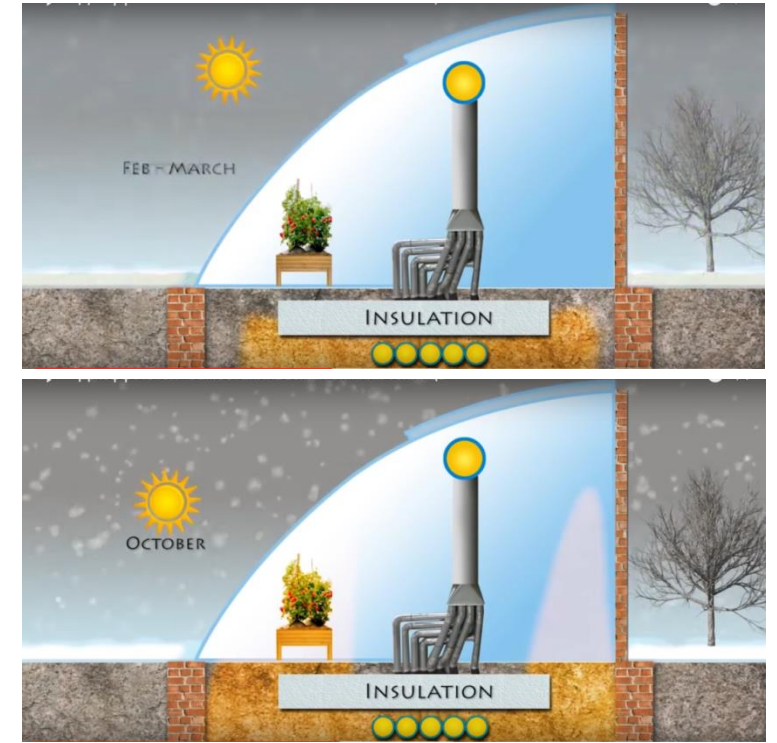
The principle of the seasonal heat storage heat
